Development of aerodynamic bearing support for application in air cycle machines

J. Šimek^{a,*}, P. Lindovský^b

^aTECHLAB Ltd., Sokolovská 207, 190 00 Praha, Czech Republic

Air cycle machines (ACM) are used in environmental control system of aircrafts to manage pressurization of the cabin. The aim of this work is to gain theoretical and experimental data enabling replacement of rolling bearings, which require lubrication and have limited operating speed, with aerodynamic bearing support. Aerodynamic bearings do not pollute process air and at the same time allow achieving higher operating speed, thus enabling to reduce machine mass and dimensions. A test stand enabling the verification of aerodynamic bearing support properties for prospective ACM was designed, manufactured and tested with operating speeds up to 65 000 rpm. Some interesting features of the test stand design and the test results are presented. A smaller test stand with operating speed up to 100 000 rpm is in design stage.

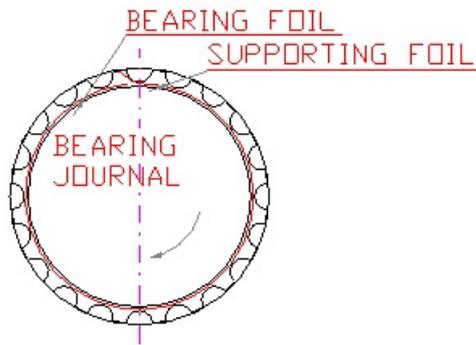
Fig. 1. Typical foil bearing

Most air cycle machines use foil bearings [1–3], which have some unique properties, namely possibility of adaptation to operating conditions and excellent dynamic properties due to additional damping caused by friction between the bearing and supporting foils (see Fig. 1) and between the supporting foil and the bearing casing. Both bearing and supporting foils are deformed by the generated aerodynamic pressure. As the bearing gap and at the same time bearing properties change with speed, it is relatively difficult to calculate bearing characteristics.

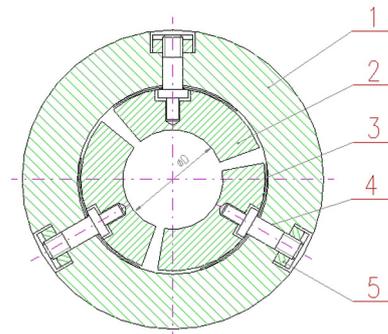
Fig. 2. Tilting pad bearing (ESTP)

However, even better dynamic properties have tilting pad journal bearings with elastically supported pads (Fig. 2) described in detail in [4]. They combine excellent stability of tilting pad bearings, as a result of very small cross coupling stiffness terms, with positive properties of foil bearings, namely possibility to adapt itself to changed operating conditions and additional damping due to friction of elastic elements on bearing casing.

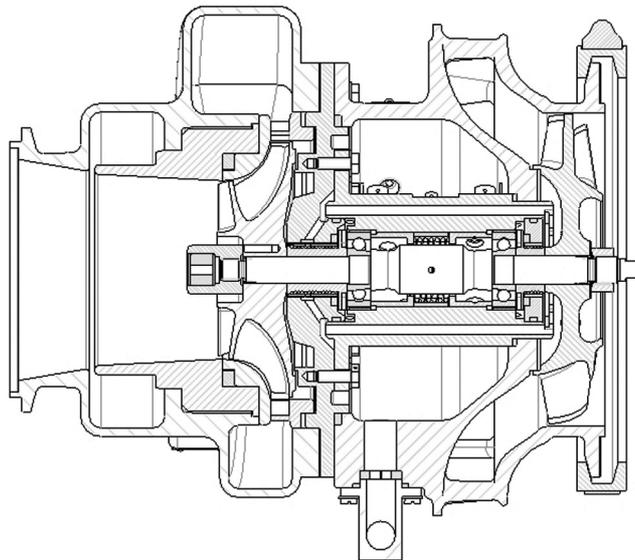
Fig. 3. Original ACM with rotor supported in rolling bearings

As can be seen in the original design of ACM in Fig. 3, the rotor with the turbine (left) and blower (right) impeller was supported in two angular contact rolling bearings preloaded by the spring. Rolling bearings were replaced by aerodynamic journal bearings with elastically supported tilting pads (ESTP) and aerodynamic spiral groove thrust bearings.

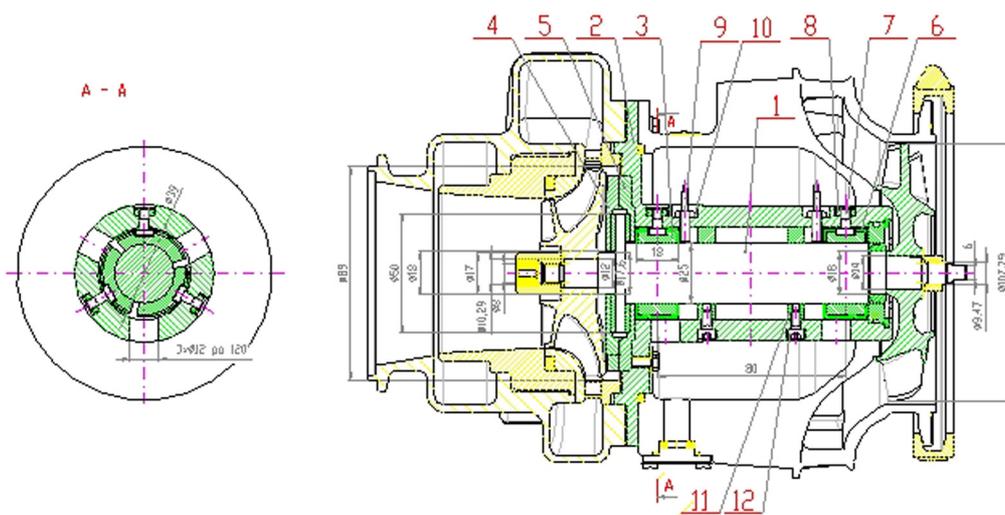
Fig. 4. Test stand with aerodynamic bearing support

ACM designed as a test stand for verification of bearing properties [5] is presented in Fig. 4. The rotor is supported in two aerodynamic tilting pad bearings, and axial forces are taken up by double-sided aerodynamic spiral groove thrust bearing 4, 5. The bearing pads 3 are supported on the elastic elements 6, which are deformed to required shape by means of pins 7 and nuts 8. The difference between the inner radius of the bearing casing 2 and the outer radius of the pad enables the rolling of pads on elastic element inner surface, so that they can tilt in circumferential direction. The elastic elements are preloaded to such an extent that maximum pad load capacity exceeds the force necessary for elastic element deformation. In case that the bearing clearance is reduced to a dangerously low value, elastic elements make it possible to restore the bearing clearance back to its safe value. Friction between the elastic elements and bearing body contributes to the damping of a gas film, similarly as in the foil bearings. Moreover, the overall damping is further increased by the squeeze effect of gas pushed out of the gap between the elastic elements and the bearing body.

The aerodynamic thrust bearings 4 a 5 substitute to some extent original labyrinth seal, because they prevent the air to flow from the turbine (left impeller) to the blower (right impeller) side. However, this was the cause of unexpected problems with the axial force magnitude. The maximum axial force directed to the turbine is higher than the axial load acting in the opposite direction and therefore, it is beneficial that the thrust bearing 4 could have bigger sliding surface (lower inner diameter) than the other one.

As is evident from the cross section in Fig. 4, the test stand is equipped with relative sensors for the detection of rotor vibrations $\underline{9}$ located next to both journal bearings. There are two pairs of Micro-epsilon S04 sensors working on eddy current principle oriented 90° apart. This orientation enables to display the trajectory of rotor centre in the bearing. Because the rotor vibrations had very low level and the trajectories were distorted by disturbances, they were not evaluated. Beside radial vibrations of the rotor, excursions in axial direction were also followed by the eddy current sensor. Certain correlation between the axial shift and tilting of rotor axis can be observed [7]. Rotor run-up from about 9 000 to almost 17 000 rpm is shown in Fig. 13.

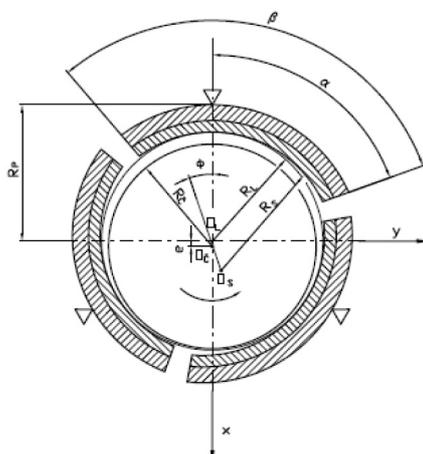
Fig. 5. TPJ bearing geometry

The journal bearings have the diameter of 25 mm and the width to diameter ratio of 0.72. Manufacturing clearance in the range 0.035 to 0.040 mm was selected due to relatively low speed. The Manufacturing clearance defined as $c_S = R_S - R_C$ is an important design parameter together with the bearing preload $\delta = 1 - c_L/c_S$, where $c_L = R_L - R_C$ (variable designation in Fig. 5).

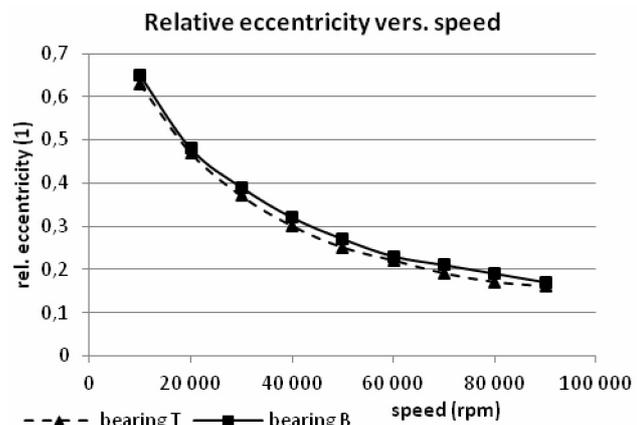
Fig. 6. Relative eccentricity in journal bearings

The diagram in Fig. 6 shows the relative eccentricity (eccentricity relative to the bearing clearance) of the journal in both bearings, which is almost the same because of not much differing load. It can be seen that with increasing speed, the relative eccentricity decreases to very small values — the journal centre is almost in the centre of the bearing.

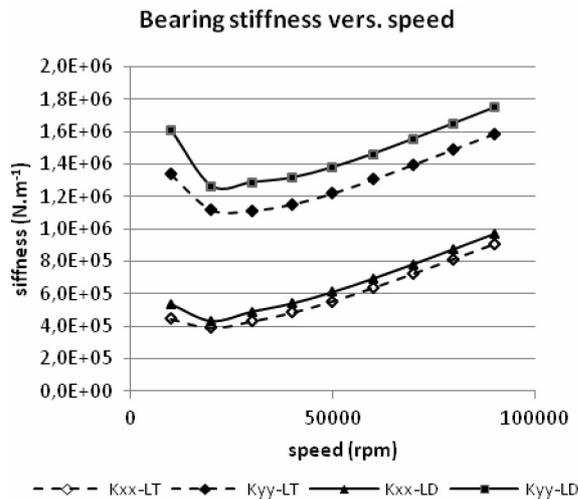
Fig. 7. Bearing stiffness coefficients

The bearing dynamic properties represented by the stiffness and damping coefficients calculated by the program “DATPJB” are shown in the diagrams in Figs. 7 and 8. Principal bearing stiffness and damping coefficients are shown in dependence on speed. It is evident that in contrast to the stiffness coefficients of hydrodynamic tilting pad bearings, aerodynamic bearings have the element K_{xx} lower than the K_{yy} one. It is due to the bearing geometry with only 3 pads, whereas the hydrodynamic bearings have 4 or 5 pads. With the exception of the lowest speeds, the bearing stiffness increases with increasing speed. The bearing damping is decreasing monotonously with increasing speed, which is standard for all sliding bearings. The calculated bearing stiffness and damping coefficients are used in the calculation of rotor dynamics.

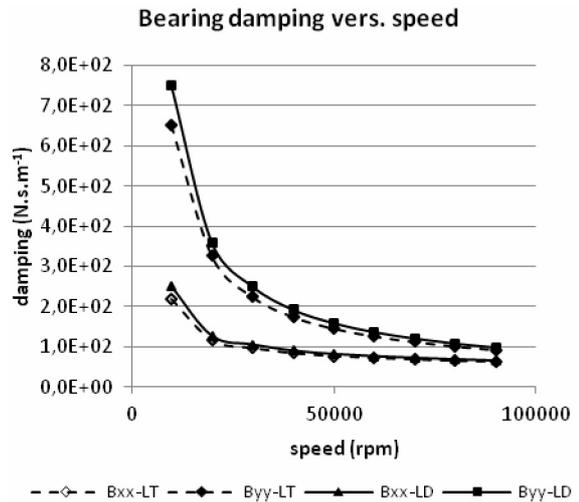
Fig. 8. Bearing damping coefficients

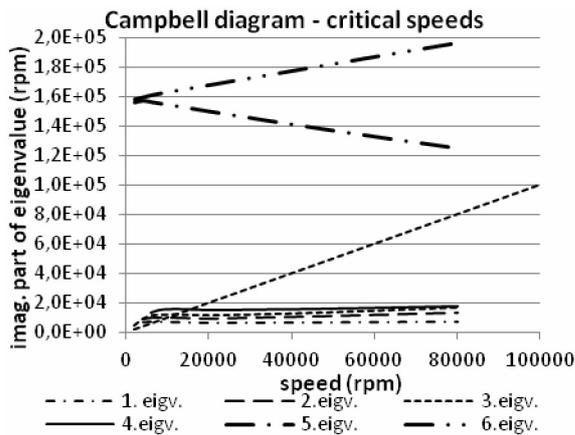
Fig. 9. Campbell diagram of critical speeds

Due to low damping, rotors in aerodynamic bearings cannot pass through the bending critical speed. Moreover, the 1st bending critical speed should be at least 60 % above the maximum operating speed; otherwise one could expect problems with excessive vibrations due to the start of rotor bending. This requirement and the achievement of rotor stability are, therefore, the two most important aspects of dynamic analysis [6]. The analysis showed four “bearing” critical speeds, i.e., critical speeds of rigid rotor on gas film, which are situated in the range from 6900 to 11900 rpm and are well damped. The rotor exhibits somewhat unorthodoxly positioned bending critical speeds, because apart from the 1st bending critical speed of counter-rotating precession at 113700 rpm, the next critical speed is counter-rotating precession with the 2nd bending mode at 197100 rpm. The 1st bending critical speed of co-rotating precession is at 261800 rpm, i.e., more than 400 % above the operating speed. According to the Campbell diagram in Fig. 9, the critical speeds of 113700 and 261800 rpm are two branches of one eigenvalue split by the gyroscopic moments. The vibration mode at 197100 rpm (not shown in the Campbell diagram) is the typical 2nd one (sine wave), while the vibration mode at 261800 rpm is typically the 1st one.

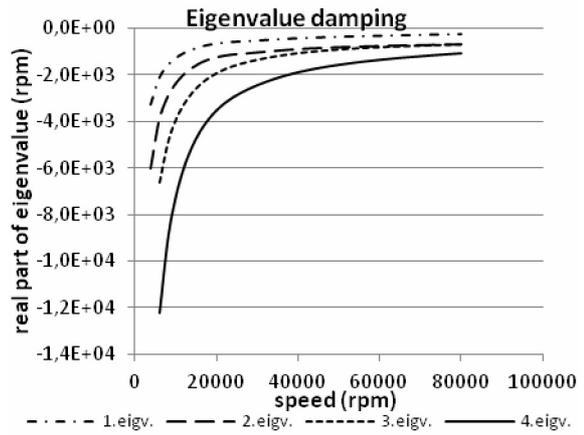
Fig. 10. Damping of critical speeds

As is evident from Fig. 10, which shows the eigenvalue damping, real parts of the four lowest eigenvalues are negative, which means that the rotor operation is stable. The stability

At the speed of 60 000 rpm, the two lowest eigenvalues have the stability reserve of 10 % and 13.8 %, respectively, which should be quite sufficient for safe operation. The stability reserve of 10 % is generally considered to be safe for stable rotor operation. However, in some previous applications, rotors operated securely with stability reserve around 5 %. Rotor operability was also confirmed with a calculated response to unbalance. The residual unbalance for a rotor with the maximum operating speed of 60 000 rpm according to the class G2.5 of ISO 1940 standard is 0.38 g.mm. This unbalance was divided between the turbine and the blower impellers in ratio of their masses. The rotor response to static unbalance (unbalances in-phase) and dynamic unbalance (unbalances out-of-phase) in dependence on speed is shown in Figs. 11 and 12. It can be seen that up to 80 000 rpm, there is no resonance peak with the exception of the speed interval around 15 000 rpm with well damped critical speeds of rigid rotor on a gas film.

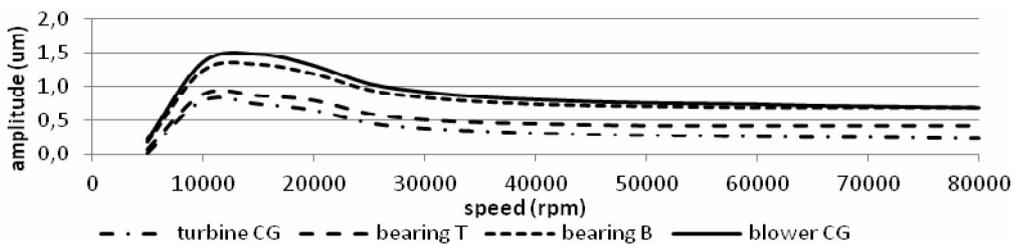
Fig. 11. Rotor response to static unbalance

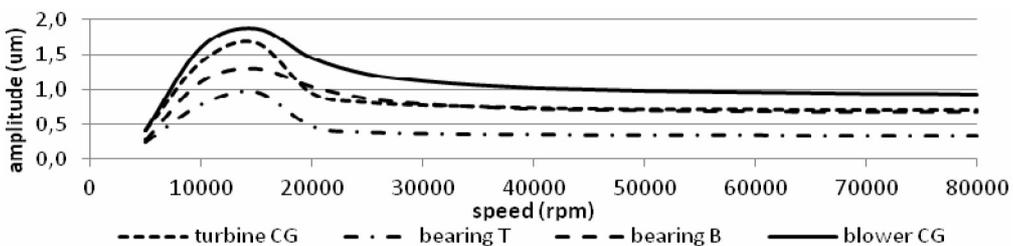
Fig. 12. Rotor response to dynamic unbalance

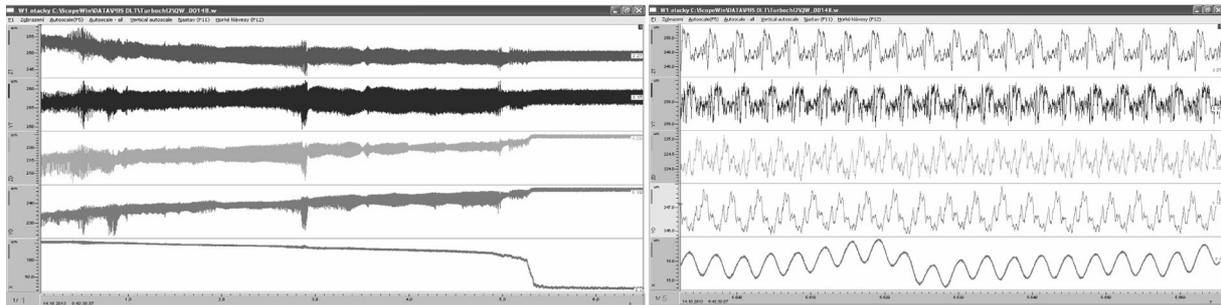
Fig. 13. Run-up of the rotor, generation of the full aerodynamic film at about 16 000 rpm

Top down in Fig. 13 and all following records of vibrations are signals:

- turbine bearing – horizontal direction,
- turbine bearing – vertical direction,
- blower bearing – horizontal direction,
- blower bearing – vertical direction,
- axial direction.

Expanded signals in the right diagram of Fig. 13 show a situation with a fully developed air film. Small disturbances can be seen in all vibration signals in the radial direction, which can be attributed to material properties changing around the shaft periphery. Fig. 14 presents rotor acceleration from 35 500 to 42 200 rpm. The change of axial force direction took place at about 39 000 rpm, which also brought about relatively great shift in the radial direction, such as the one in the bearing at the blower side. It shows that due to the pad elastic support with relatively low stiffness, the rotational axis can tilt so that thrust bearing and thrust runner sliding surfaces align to be parallel to each other.

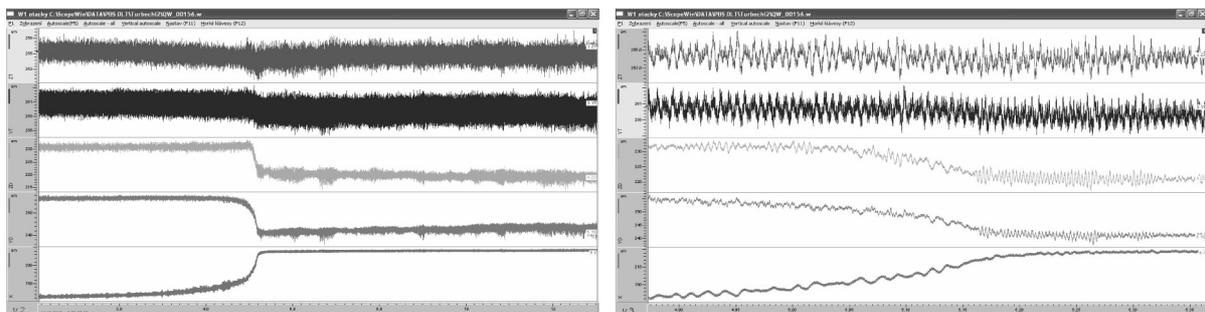
Fig. 14. Rotor acceleration from 35 500 to 42 200 rpm with change of axial force direction

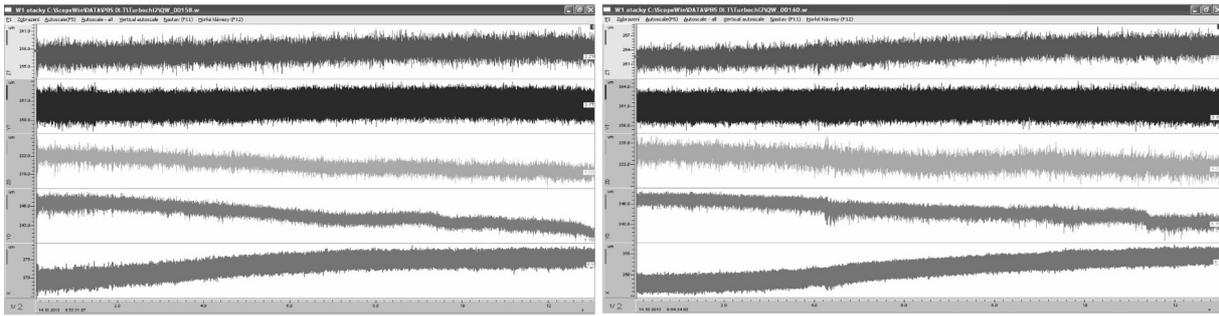
Fig. 15. Acceleration from 42 500 to 47 000 rpm and from 47 500 to 53 000 rpm

This is most important from the standpoint of thrust bearing load carrying capacity, which is very dependent on the parallelism of sliding surfaces. Tilting of rotational axis accompanying the change of axial force/axial shift can be also seen in Fig. 15 illustrating rotor acceleration from 42 500 to 47 000 rpm and from 47 500 to 53 000 rpm. The maximum radial shift occurs in horizontal direction. Similar rotor behaviour follows then the speed is increased from 55 000 to 59 000 rpm and from 59 400 to 63 700 rpm as shown in Fig. 16. Small increase in vibration amplitude can be seen in signals from the bearing on blower side, which could indicate that the thrust bearing load capacity is nearing its limit.

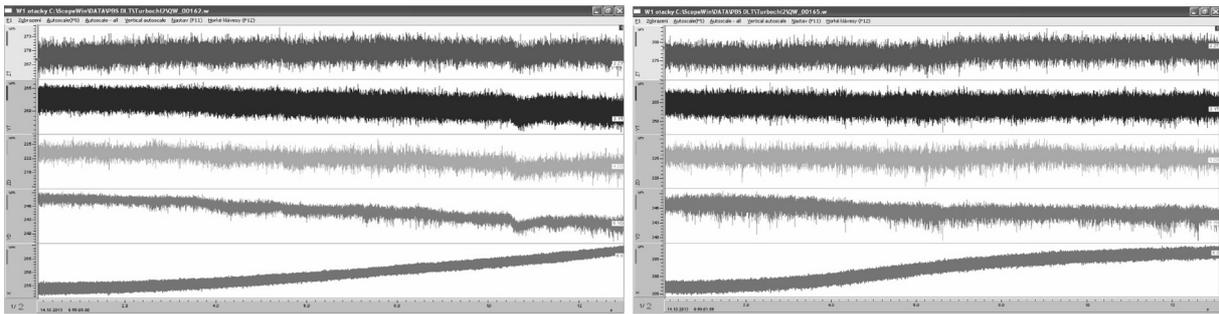
Fig. 16. Acceleration from 55 000 to 59 000 rpm and from 59 400 to 63 700 rpm

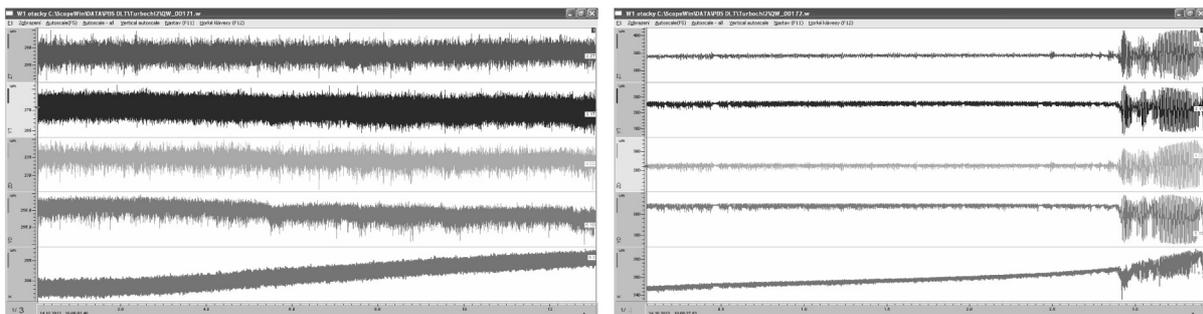
Fig. 17. Acceleration from 62 800 to 66 600 rpm; Beginning of failure at 65 000 rpm

Although the operation speed was already achieved, it was decided to increase the speed once more. Results for acceleration from 62 800 to 66 600 rpm are shown in Fig. 17. Apart from further shift in the axial direction and a slight increase in vibration amplitude in blower bearing, there were no indications of potential problems. However, after a relatively short time, the vibration amplitude dramatically increased, as shown in the right part of Fig. 17. At this point, the machine was stopped and disassembled. Essential parts of the aerodynamic bearing support after failure are shown in Figs. 18 and 19.

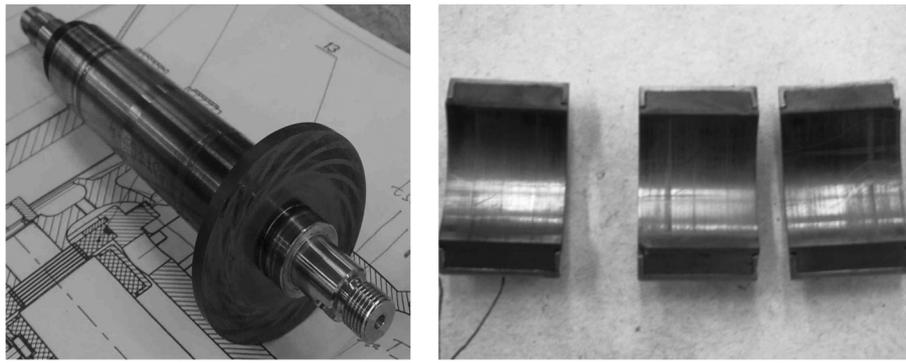
Fig. 18. Rotor with thrust disk and pads from journal bearing at blower side after failure

It can be seen that the main thrust bearing with graphite lining as well as steel thrust disk on the rotor are heavily damaged by the mutual contact at sliding speed exceeding $170 \text{ m} \cdot \text{s}^{-1}$. On the other hand, the bearing pads and opposed sliding surfaces on the rotor were quite undamaged. The failure was apparently caused by the overloading of the main thrust bearing and the subsequent contact of sliding surfaces, which resulted in substantially increased vibrations in the journal bearings within the whole clearance (including clearance of elastically supported pads in bearing casing).

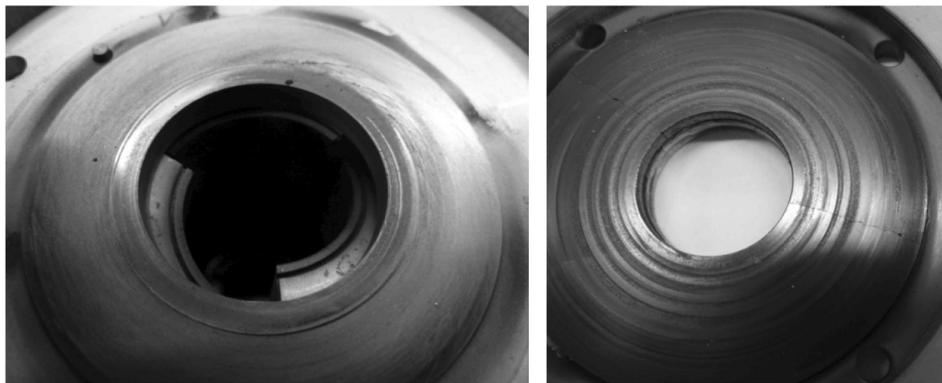
Fig. 19. Auxiliary (left) and main (right) thrust bearing after failure

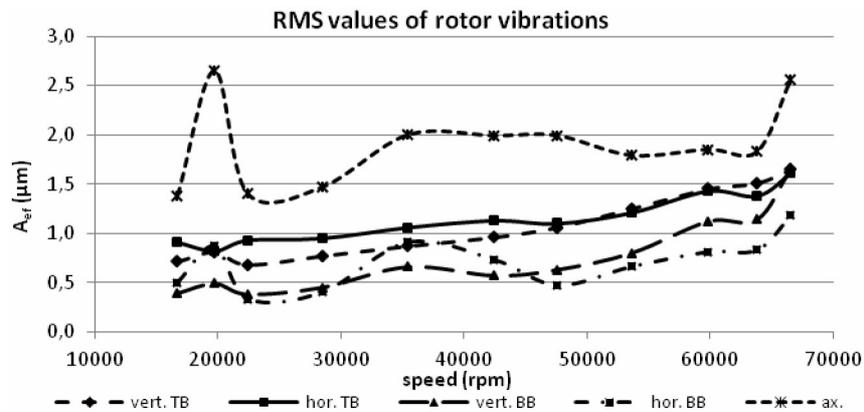
Fig. 20. RMS value of rotor vibration amplitude

As is evident from diagram in Fig. 20, the rotor vibrations up to 67 000 rpm were quite low. Curves in Fig. 20 represent the RMS values of relative vibrations in horizontal, vertical and axial directions in bearings on blower (BB) and turbine (TB) side. No RMS value of rotor

vibration amplitude in radial direction exceeded $2\ \mu\text{m}$. Vibrations in axial direction were lower than $3\ \mu\text{m}$ in the whole speed range. These data reflect the very good level of rotor balancing as well as the proper function of both the journal and thrust bearings. The only indication of thrust bearing overloading was the very slight vibration increase in the journal bearing at blower side.

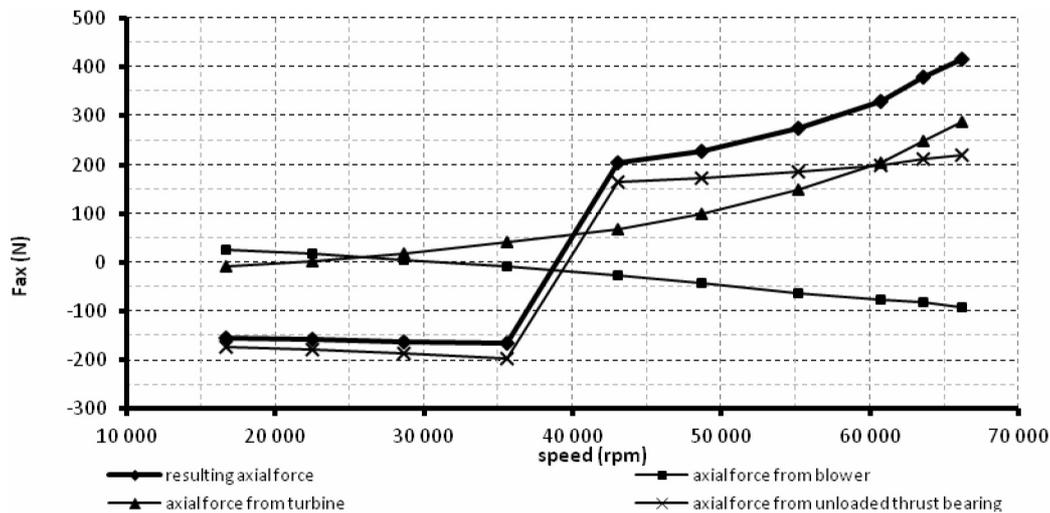
Fig. 21. Calculated axial force

According to calculation, the main thrust bearing was operating with gas film thickness lower than $3\ \mu\text{m}$, which is an extremely low value for a bearing 50 mm in diameter. The axial force acting on the thrust bearing is a resultant of pressures acting on the impellers and the unloaded part of the thrust disk. Change of axial force direction at about 40 000 rpm was caused by pressure increase at the turbine side, which was then amplified by the pressure acting on the other (now unloaded) side of the thrust disk. The development of axial force with speed is shown in diagram in Fig. 21. As can be seen from the diagram, at the speed of 65 000 rpm axial force exceeded value of 150 N, scheduled for bearing design, almost three times. The change of axial force direction around 40 000 rpm was confirmed by the measured data.

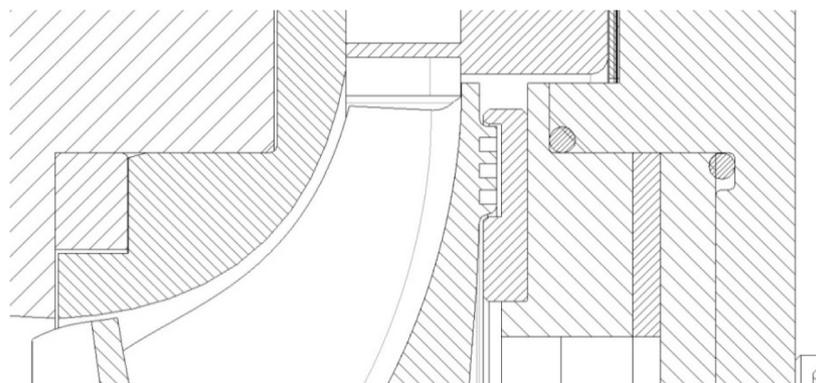
Fig. 22. Labyrinth seal behind the turbine impeller

An axial force analysis showed that it is necessary to reduce the thrust bearing load [8]. Labyrinth seal was, therefore, installed behind the turbine impeller (see Fig. 22). The tests continued by sequentially increasing the speed with similar rotor vibrations as in the previous tests. Sam-

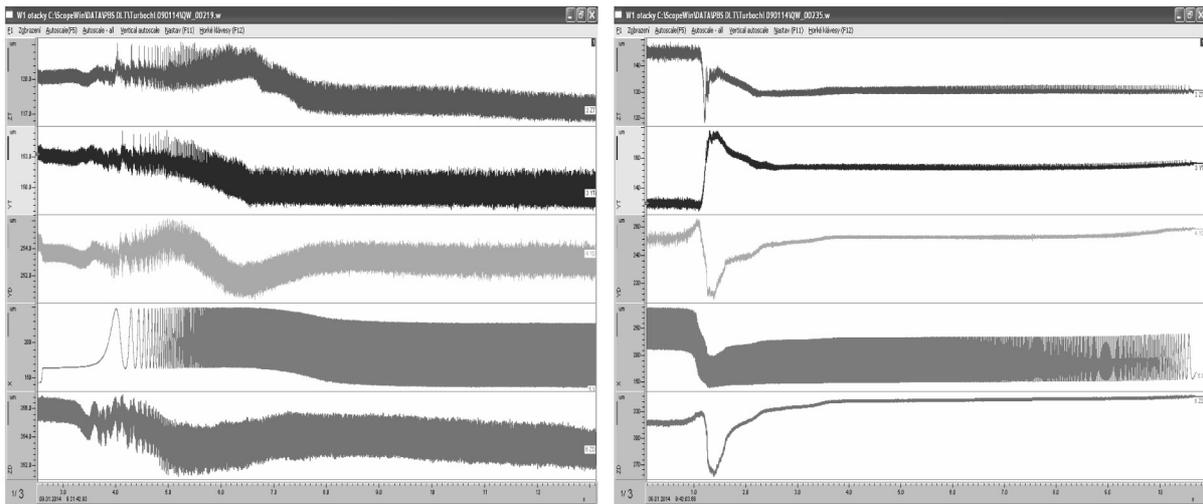
Fig. 23. Run up to 23 000 rpm and run-down from 65 000 rpm

ples of vibration signals are presented in Fig. 23. The sequence of vibration signals is the same as in the previous tests, with the exception of axial direction, which is now the 2nd one from below. The axial signal is distorted by the damage of measured surface during disassembly. There is an eccentric hole, which “provides” virtual axial vibration with amplitude of about 70 μm . It is practically impossible to assess real amplitude of axial vibrations, but axial shifts of the rotor can be still observed. Fig. 23 shows rotor run-up from stand-still to about 23 000 rpm with axial shift around 40 μm and relatively big shifts in all radial directions. The right part of Fig. 23 presents rotor run-down from maximum speed to practical stand-still. It can be seen that the change of axial force direction takes place between 59 000 rpm and 48 000 rpm. However, no change of axial force direction was encountered with increasing speed.

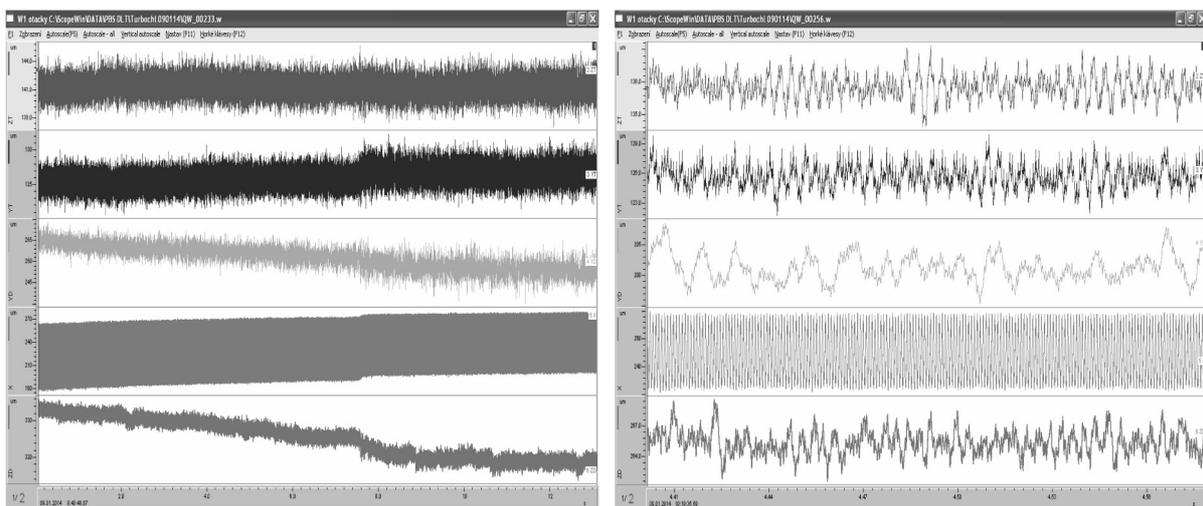
Fig. 24. Increasing speed from 57 500 to 60 200 rpm; Stable maximum speed of 65 000 rpm

Due to labyrinth seal, the axial force was significantly reduced; it still increases with increasing speed, as evident from the left part of Fig. 24 (the right part of axial force signal is higher than the left one – the rotor shifted to the blower side). However, the maximum calculated value of axial load was about 235 N; with this load value, the main thrust bearing works with a film thickness of 5 μm . The right part of Fig. 24 shows vibration signals at the stable

maximum speed of about 65 000 rpm. The peak to peak vibration amplitudes of all signals in radial direction did not exceed 5 μm . The RMS values of vibration amplitudes in radial direction in dependence on speed are presented in Fig. 25. Sensor at the blower side in horizontal direction (dotted line in Fig. 25) was damaged during the rotor failure in the 1st test and its characteristics cannot be considered as quite correct. The other 3 sensors show RMS values of vibration amplitude lower than 1.5 μm in the whole speed range, i.e., extremely small values for such a high speed.

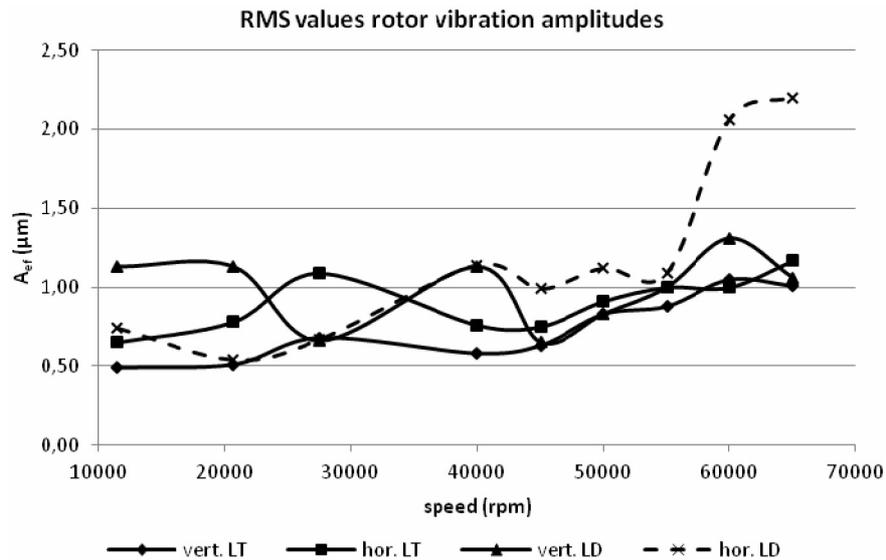
Fig. 25. RMS values of rotor vibration amplitude in radial direction vs. speed

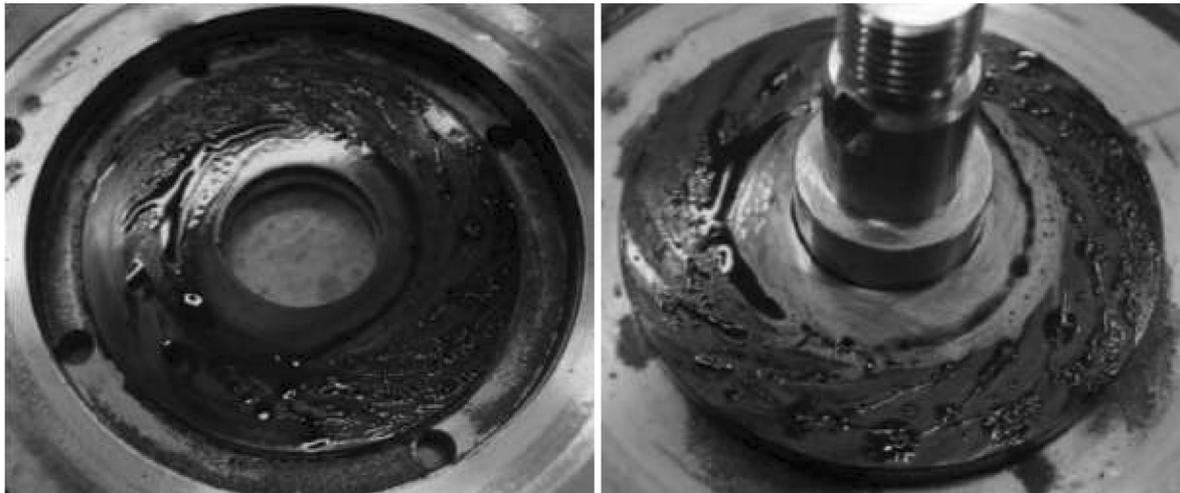
Fig. 26. Main thrust bearing and thrust disk polluted by the mixture of oil and graphite particles

1. A small amount of oil from the system of pressurized air driving the machine penetrated into main thrust bearing, as documented in Fig. 26. The oil mixed with the graphite particles loosened from the bearing lining significantly increased the starting torque during the rotor run-up. The presence of oil at the graphite lining is by no means desirable and does not reduce the wear of sliding surfaces during the run-up and run-down; it has rather the opposite effect.

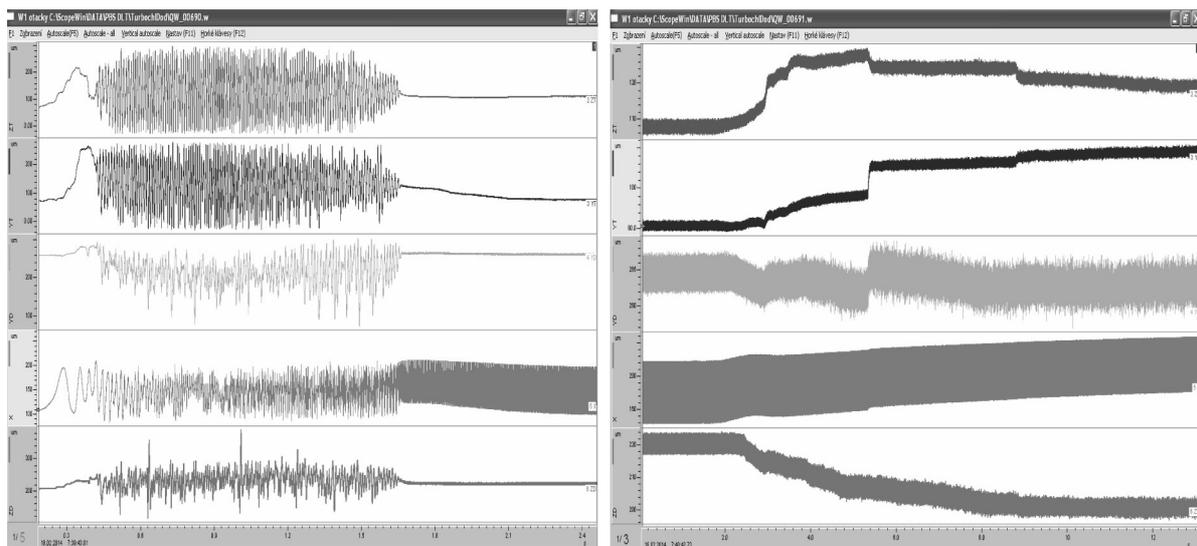
Fig. 27. Run-up from standstill to about 20 000 rpm (left); Speed increase from about 20 000 to 50 300 rpm (right)

It is quite natural that during the start up with traces of oil in the thrust bearing gap, the rotor exhibited high level of vibration before a full air film was established. It is documented in the left part of Fig. 27, showing the run-up from standstill to about 20 000 rpm. The vibration amplitudes around $200\ \mu\text{m}$ p-p in radial direction (practically in the range of the whole bearing clearance including the clearance of pads in bearing casing) are apparently caused by the contact of sliding surfaces in the auxiliary thrust bearing, which is preloaded by the main thrust bearing operating in the “hydrodynamic” regime (i.e., with oil as a process medium). As soon as the oil is thrown out of the thrust disk and a complete gas film is established in the auxiliary thrust bearing, the vibration level drops to the usual level of around $4\ \mu\text{m}$ p-p. With a further speed increase, there is no increase in vibration level, only shifts in the radial direction as the rotor aligned with the main thrust bearing sliding surface. Almost steady shift in the axial direction to the turbine impeller (last but one signal) indicates growing axial force with increasing speed.

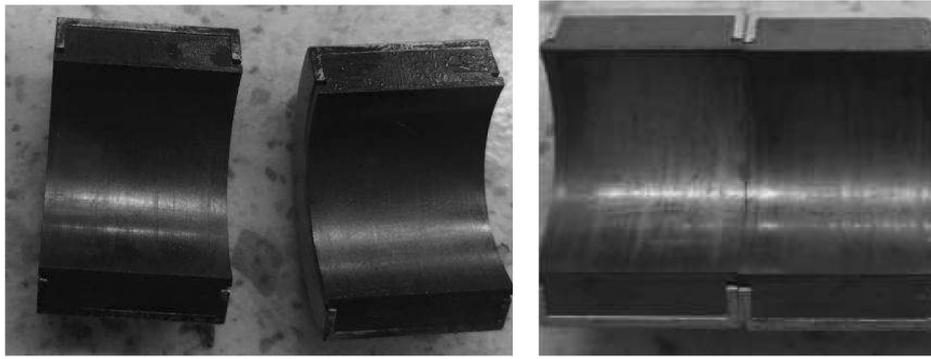
Fig. 28. Bearing pads at the turbine side (left) and blower side (right) after disassembly

As can be seen from Fig. 28, the bearing pads at the turbine side (next to the thrust bearing) were also somewhat polluted by oil in contrast to the pads from the bearing at the blower side, which stayed quite clean. After shaft cleaning, it is evident that the sliding surfaces are not damaged and neither on the thrust disk and neither on the shaft at the journal bearing locations (see Fig. 29). Traces at the outer diameter of the thrust disk indicate that there was a slight and very short contact of sliding surfaces, but the damage is very small and the rotor and bearings are able to operate further quite satisfactorily.

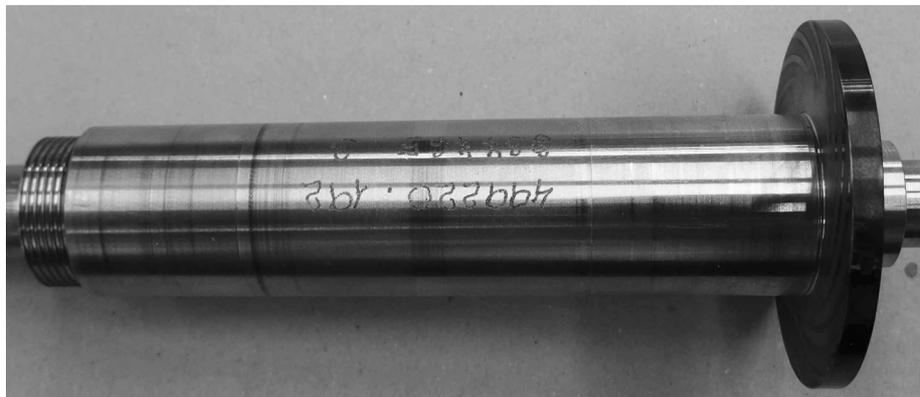
Fig. 29. Cleaned rotor

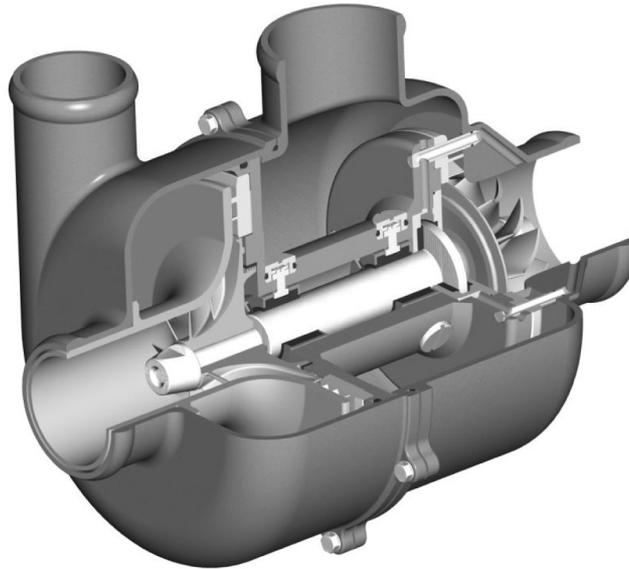
Fig. 30. Design of a smaller ACM variant

A smaller ACM with maximum operating speed of 95 000 rpm was designed and is prepared for manufacture (Fig. 30), as machine dimensions and weight are the most important parameters for flight applications.
